USCG/NOAA SARSAT CONFERENCE 2008

False Alerts

What causes False Alerts?

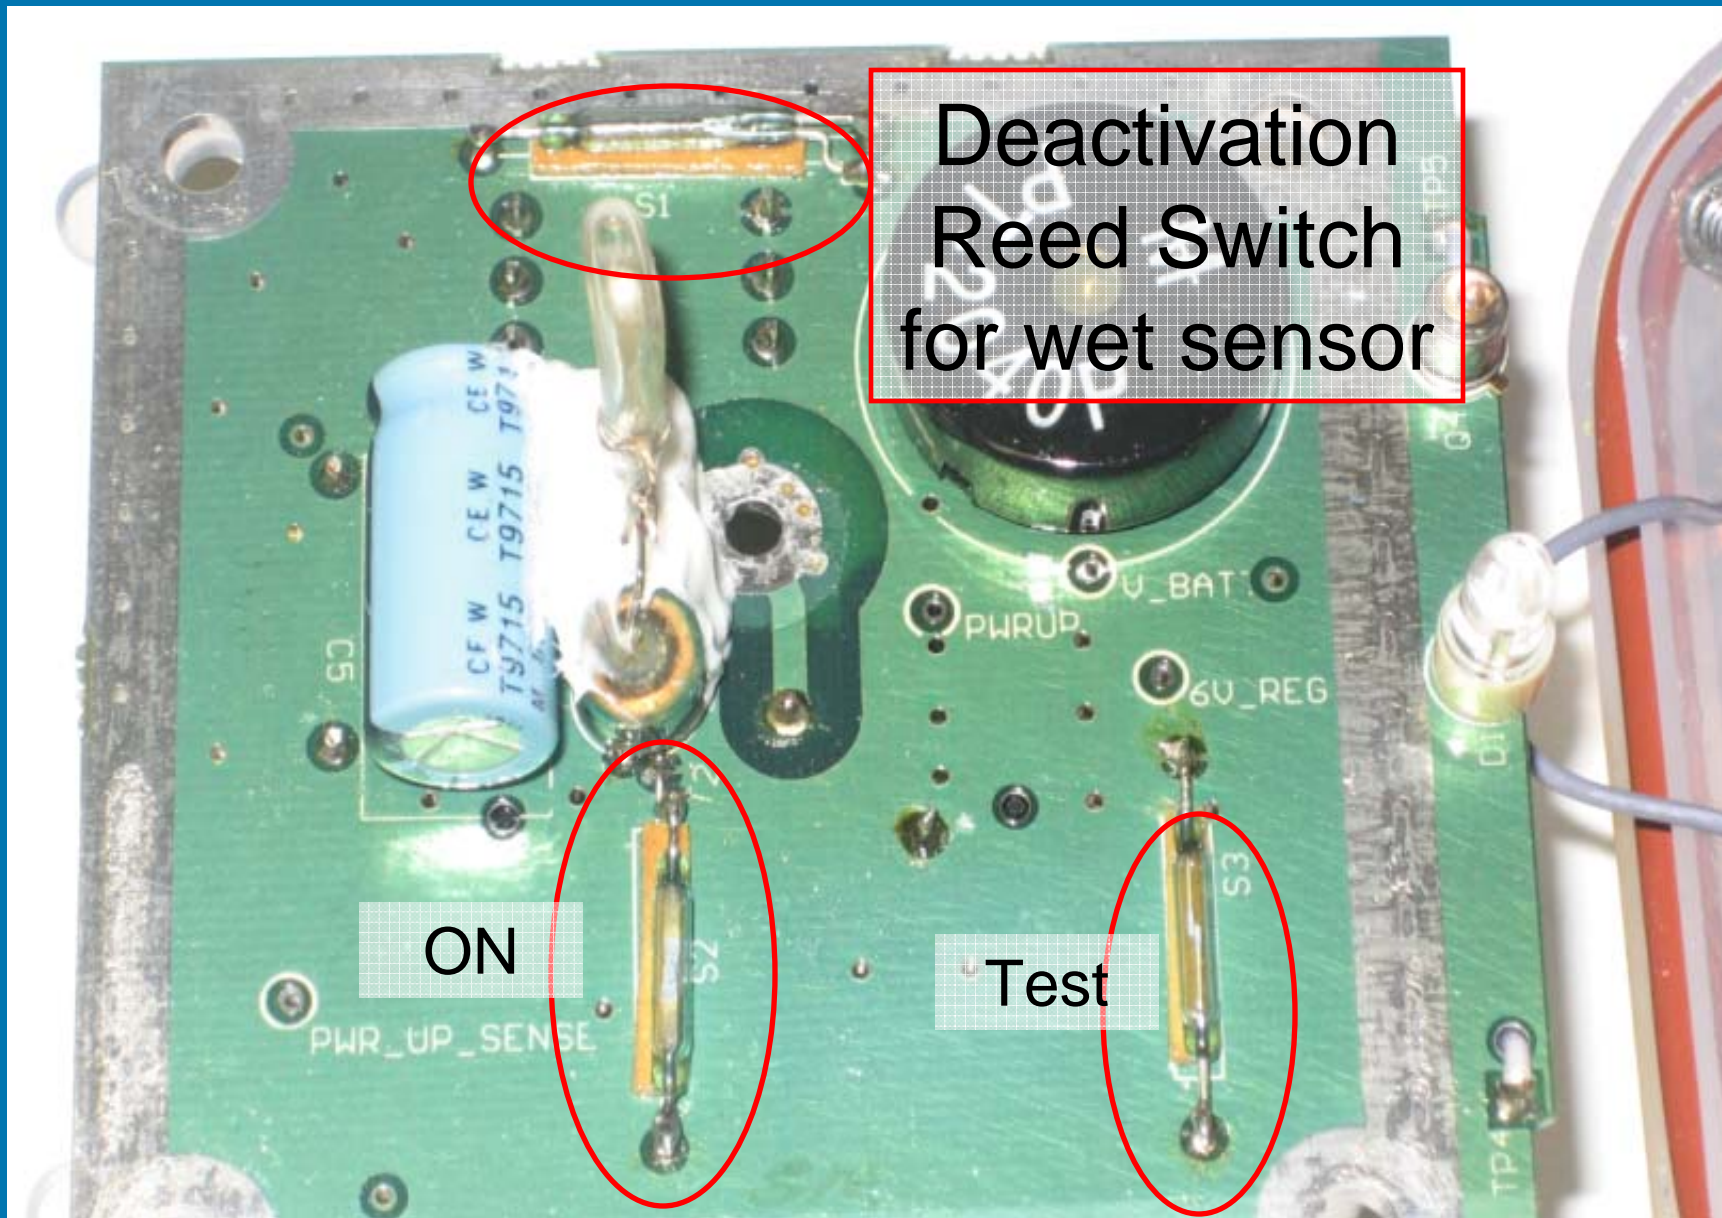
Not be activated or deactivated by conditions encountered in maritime environment.

**67% Of False Alerts
Mounting Failure.**

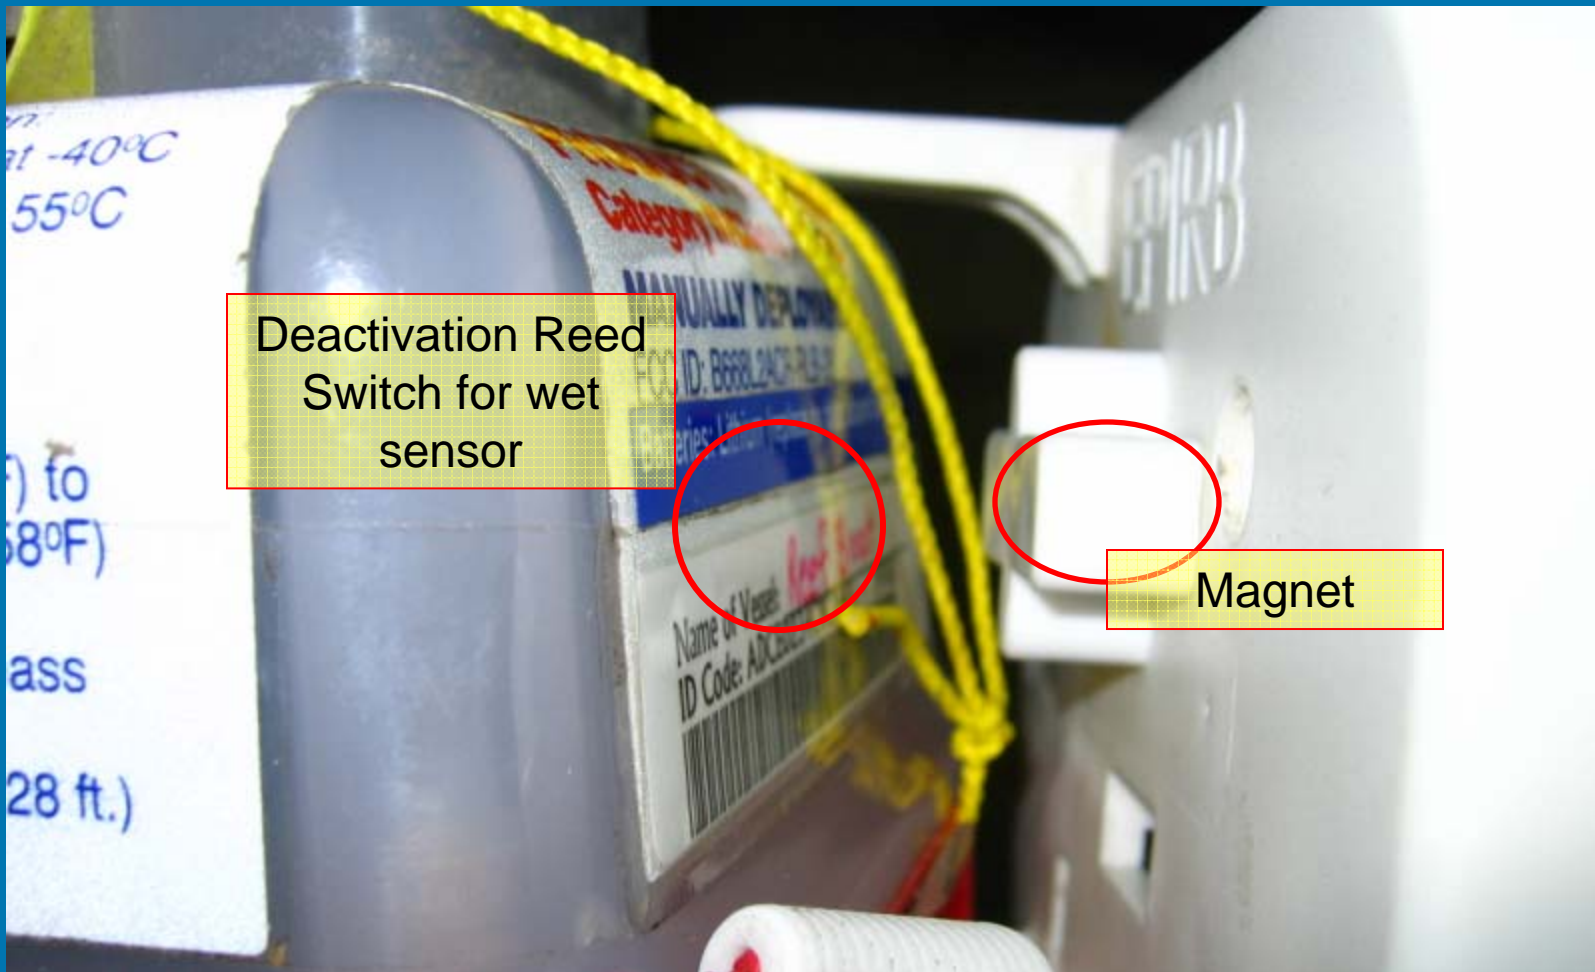
Wet Sensor Deactivation System

Deactivation
Reed Switch
for wet sensor

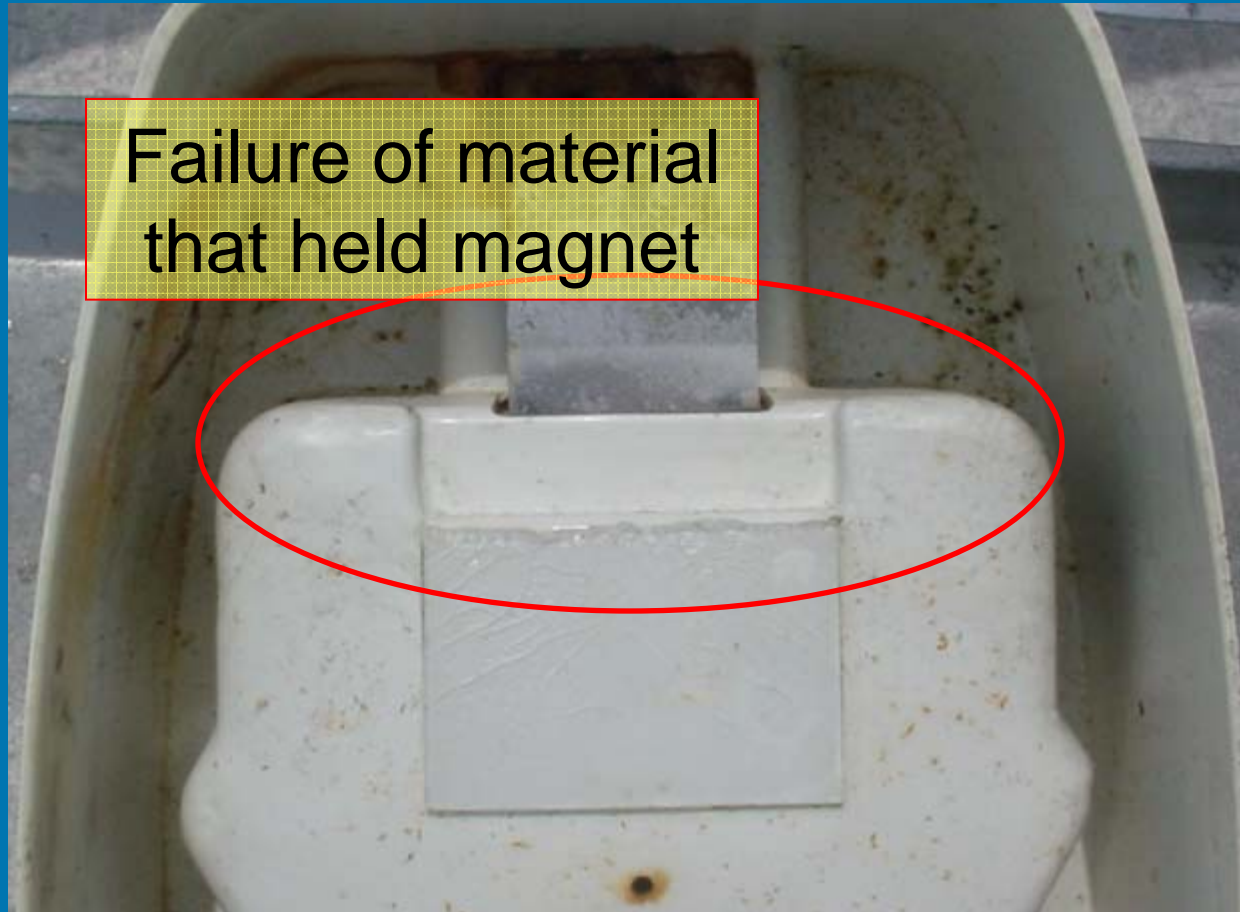
Magnet Missing

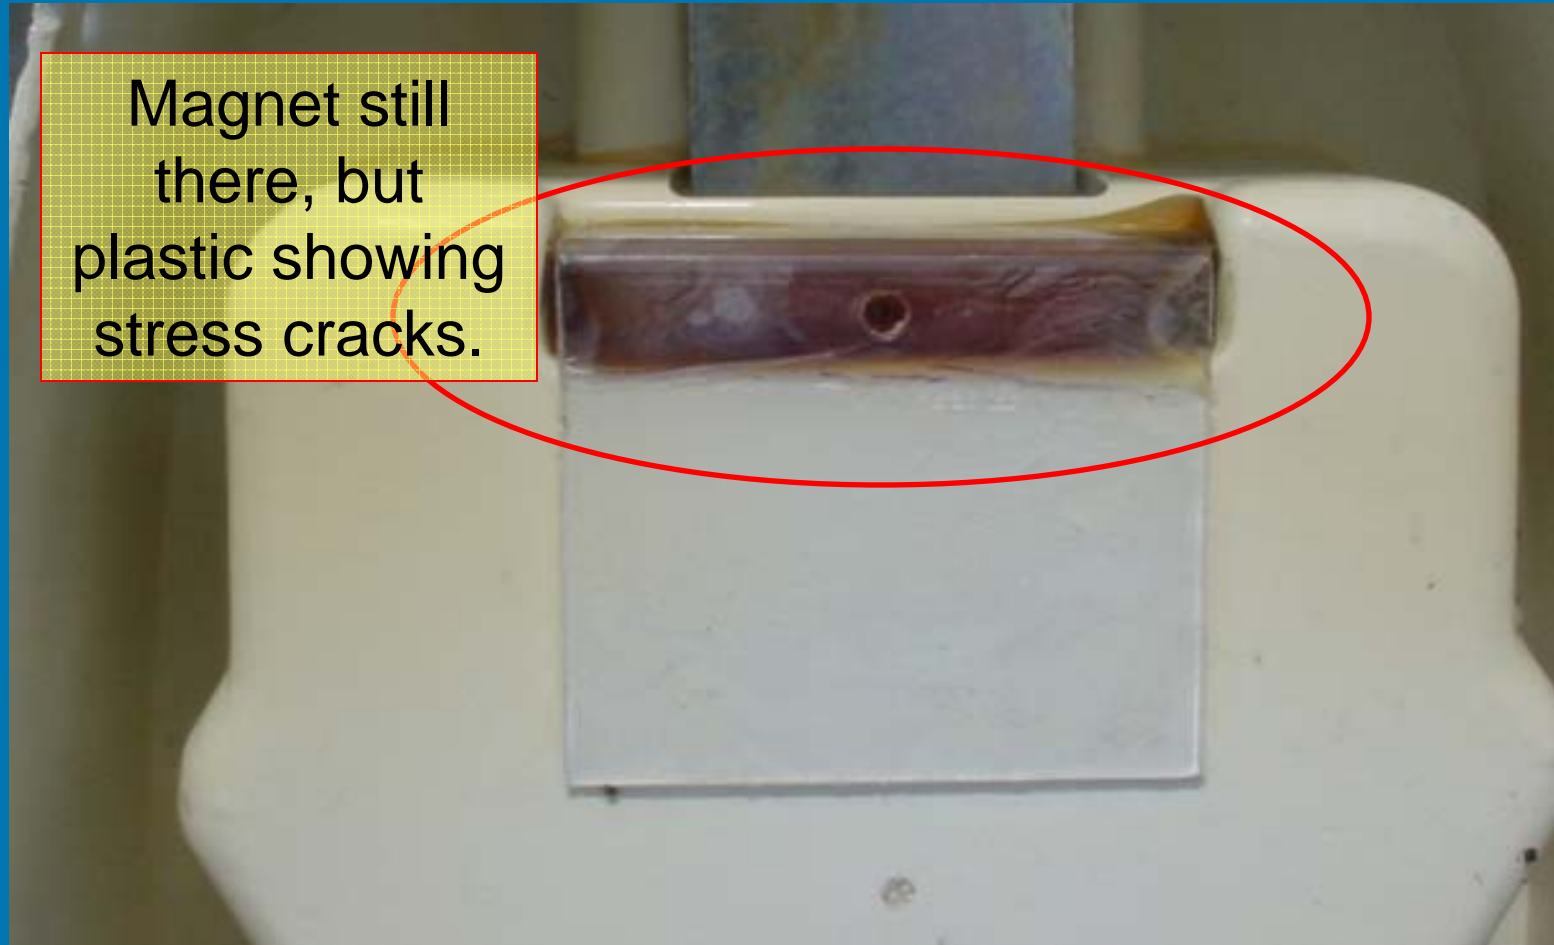
Magnet Still There

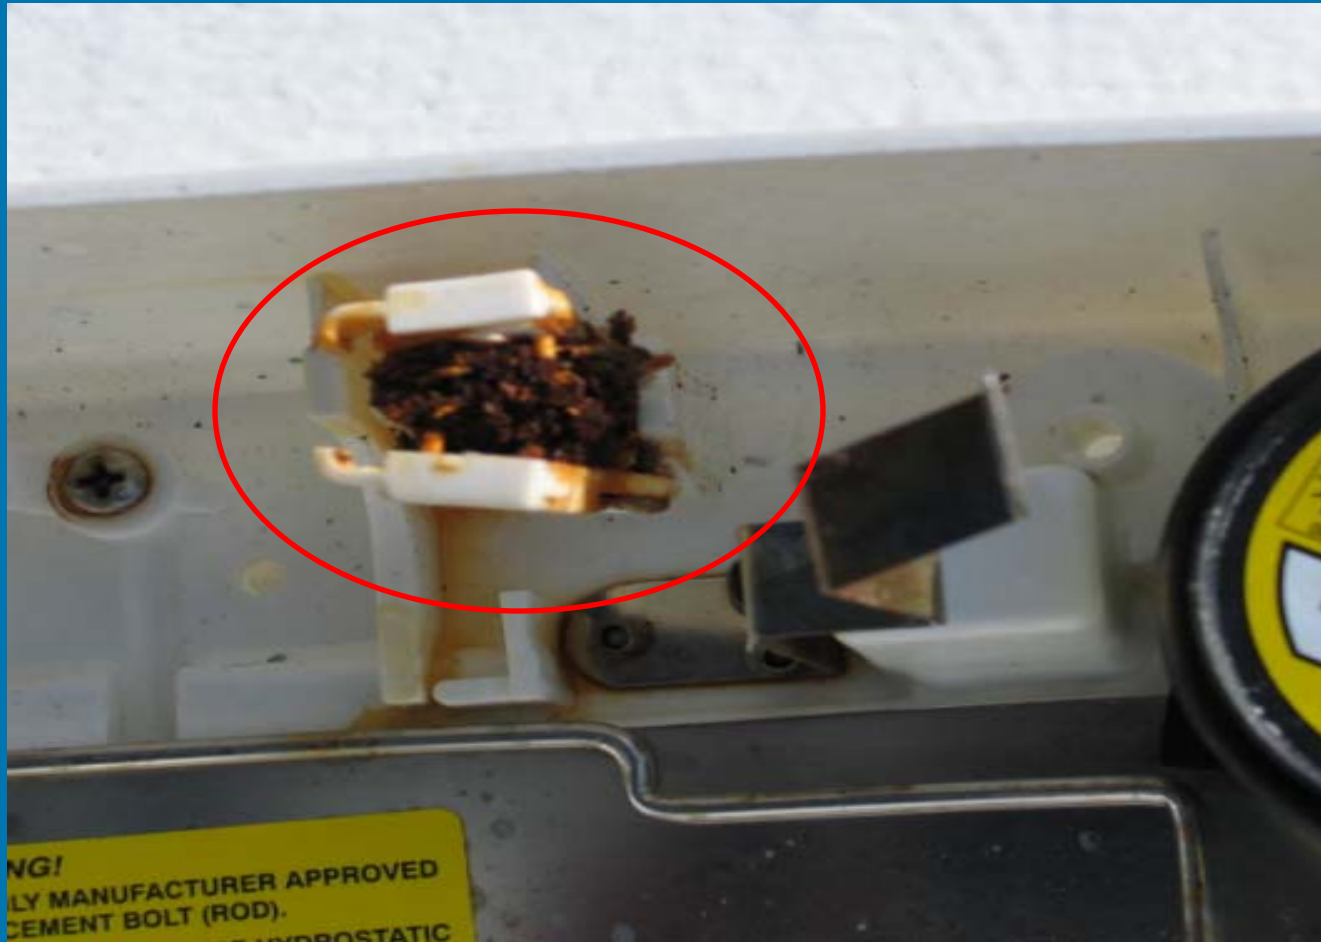
Magnet Corrosion

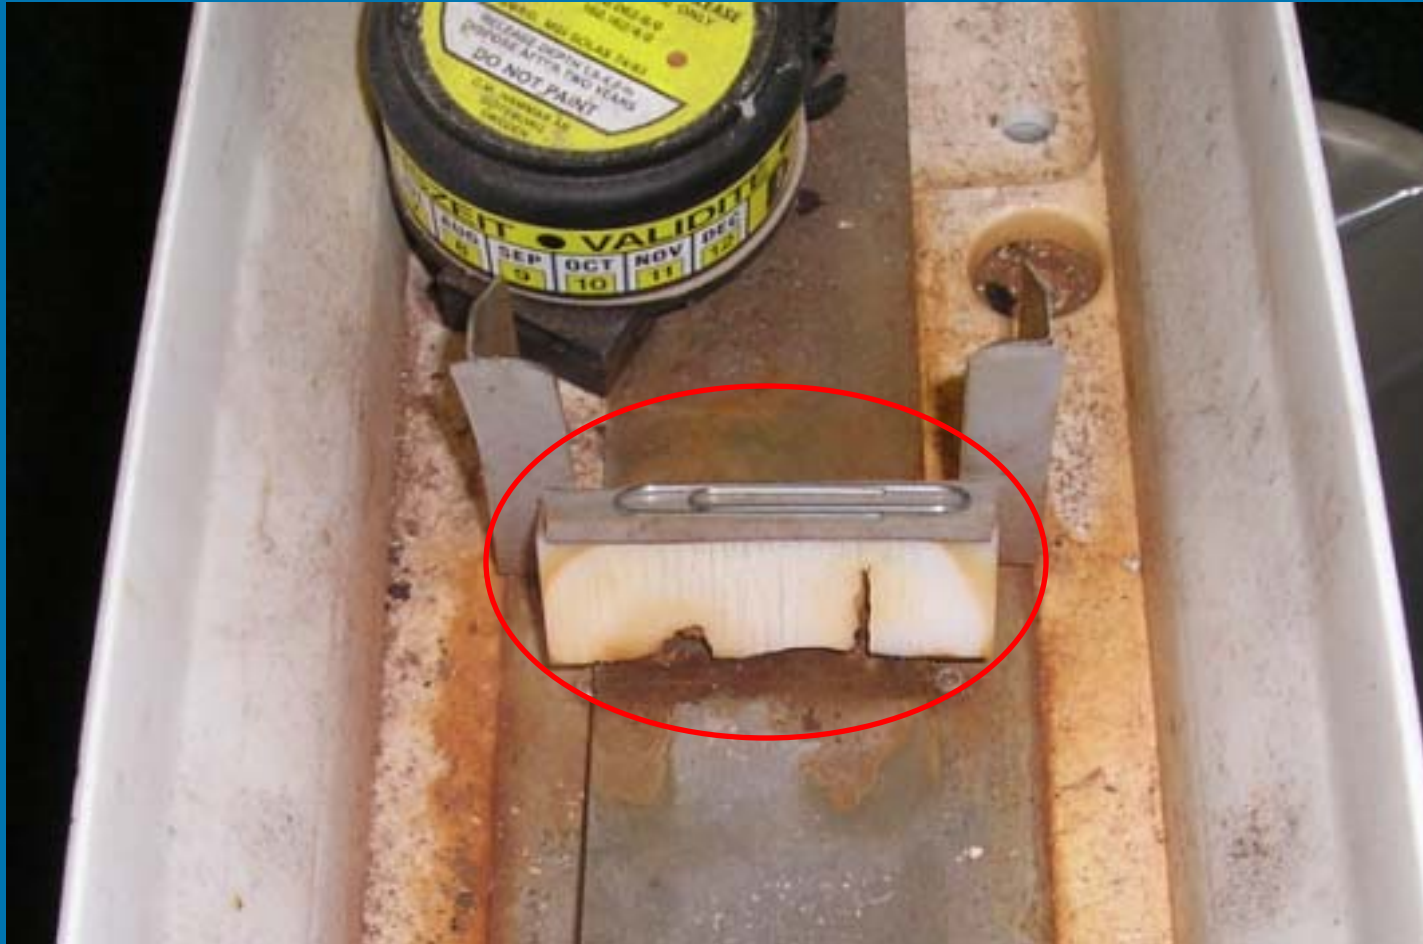
Magnet Corrosion

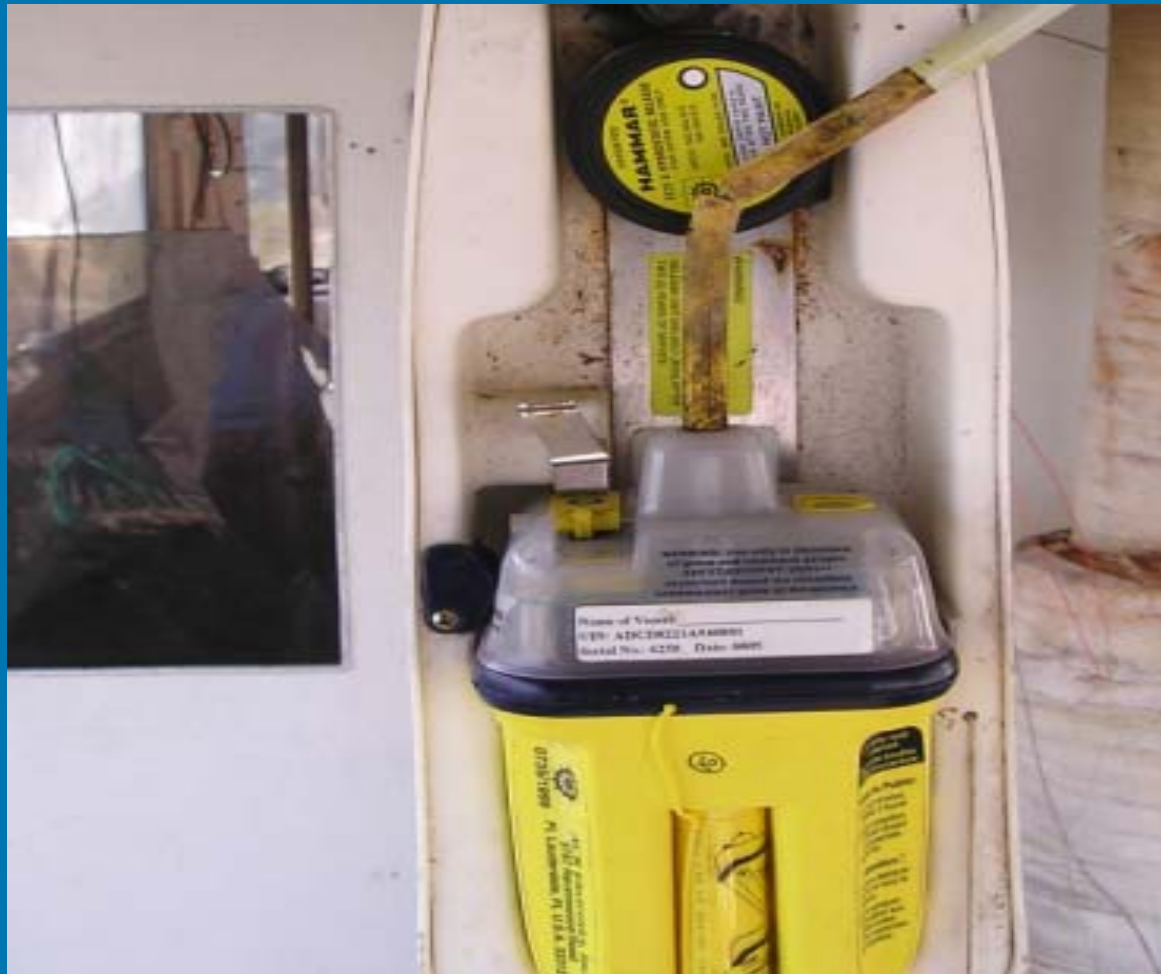
EPIRB Mounted Backward

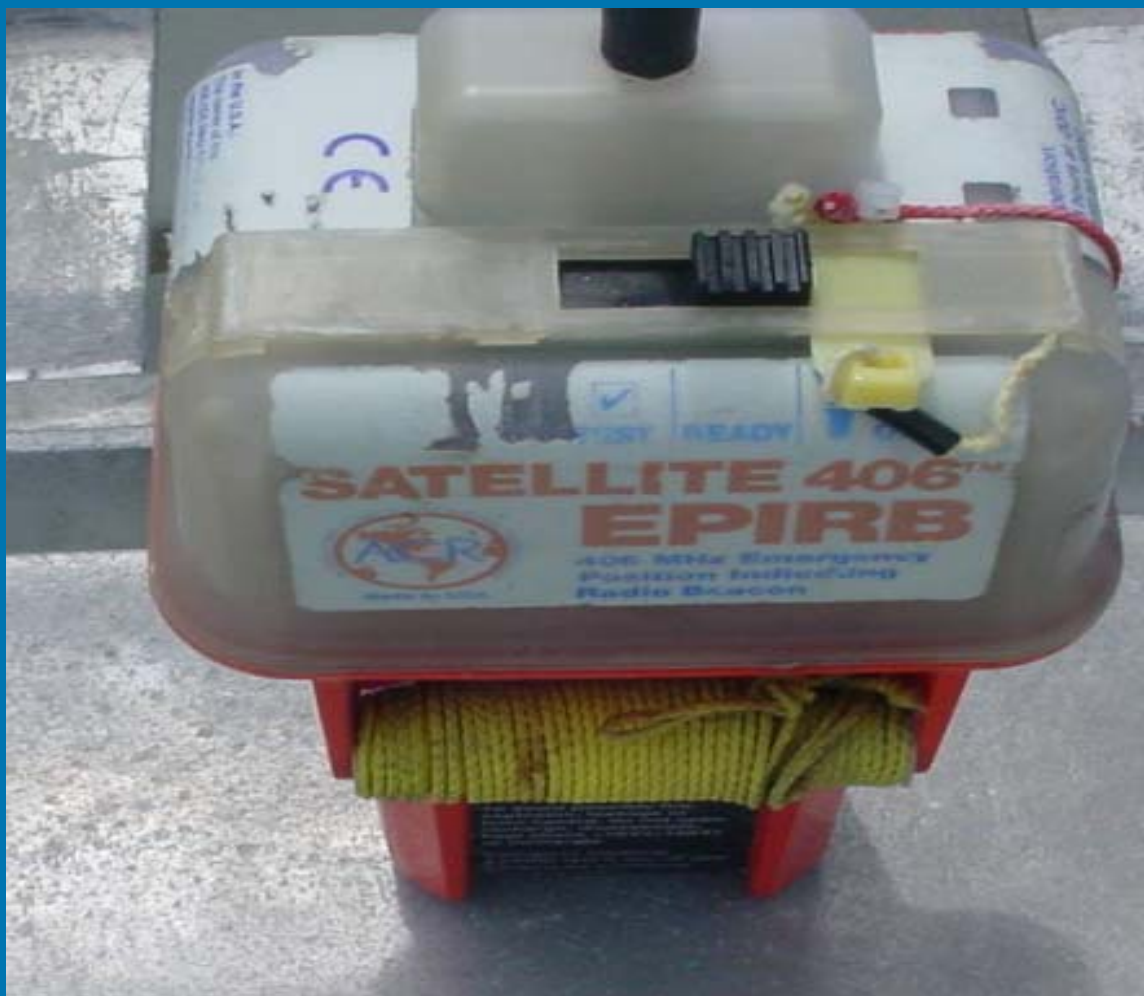
EPIRB Assembled Backward

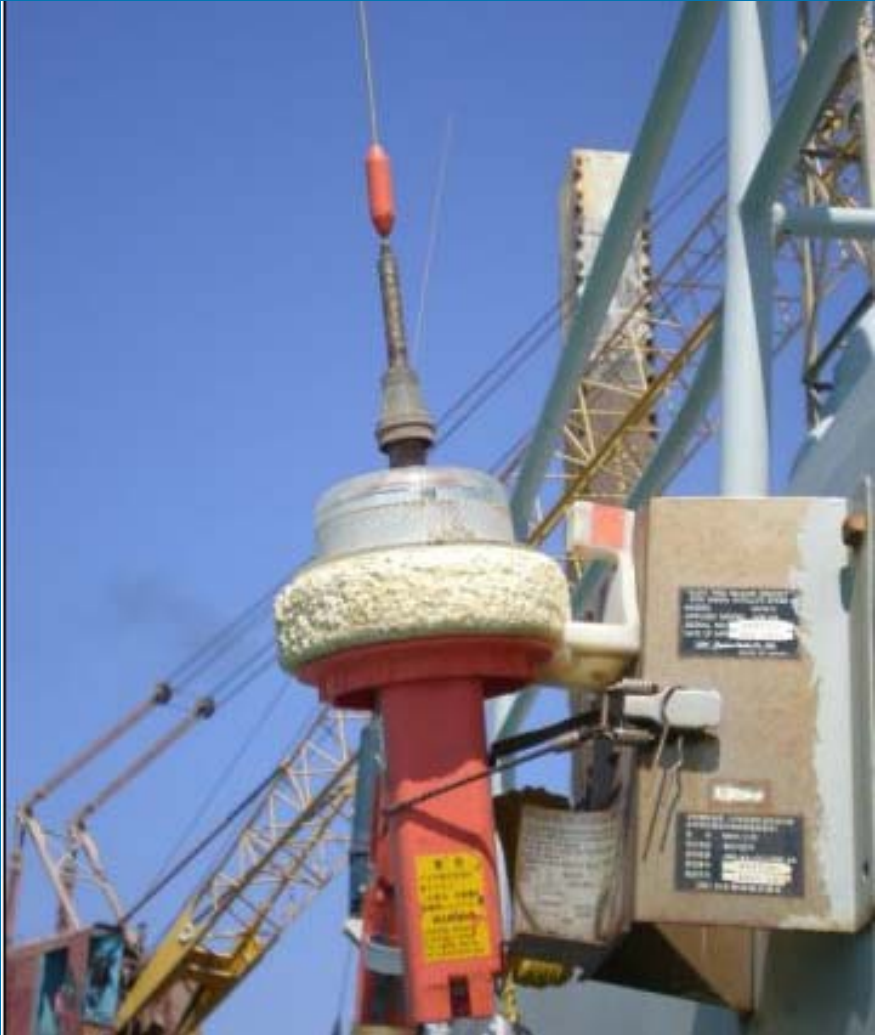
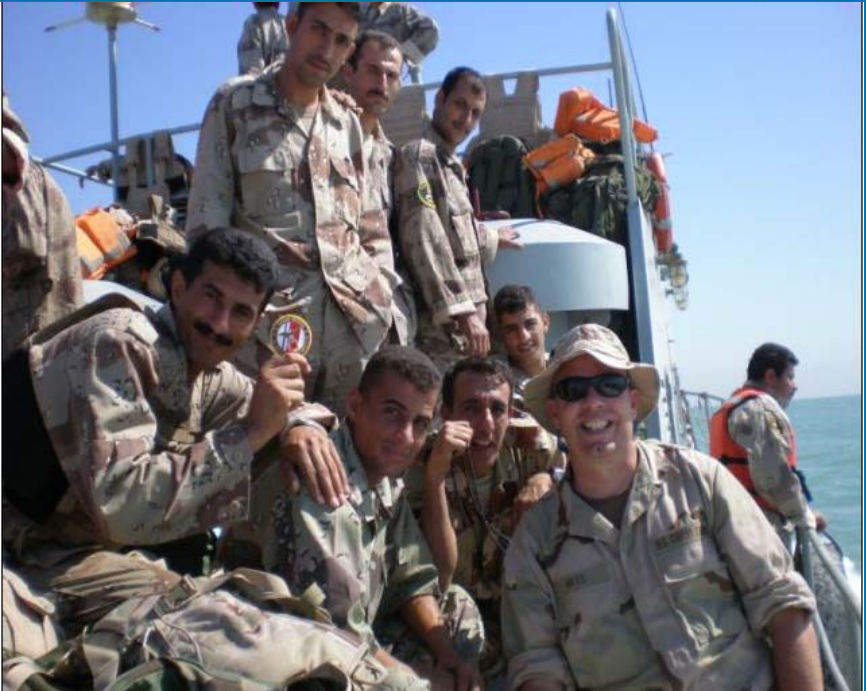
Not Just a US Problem!!

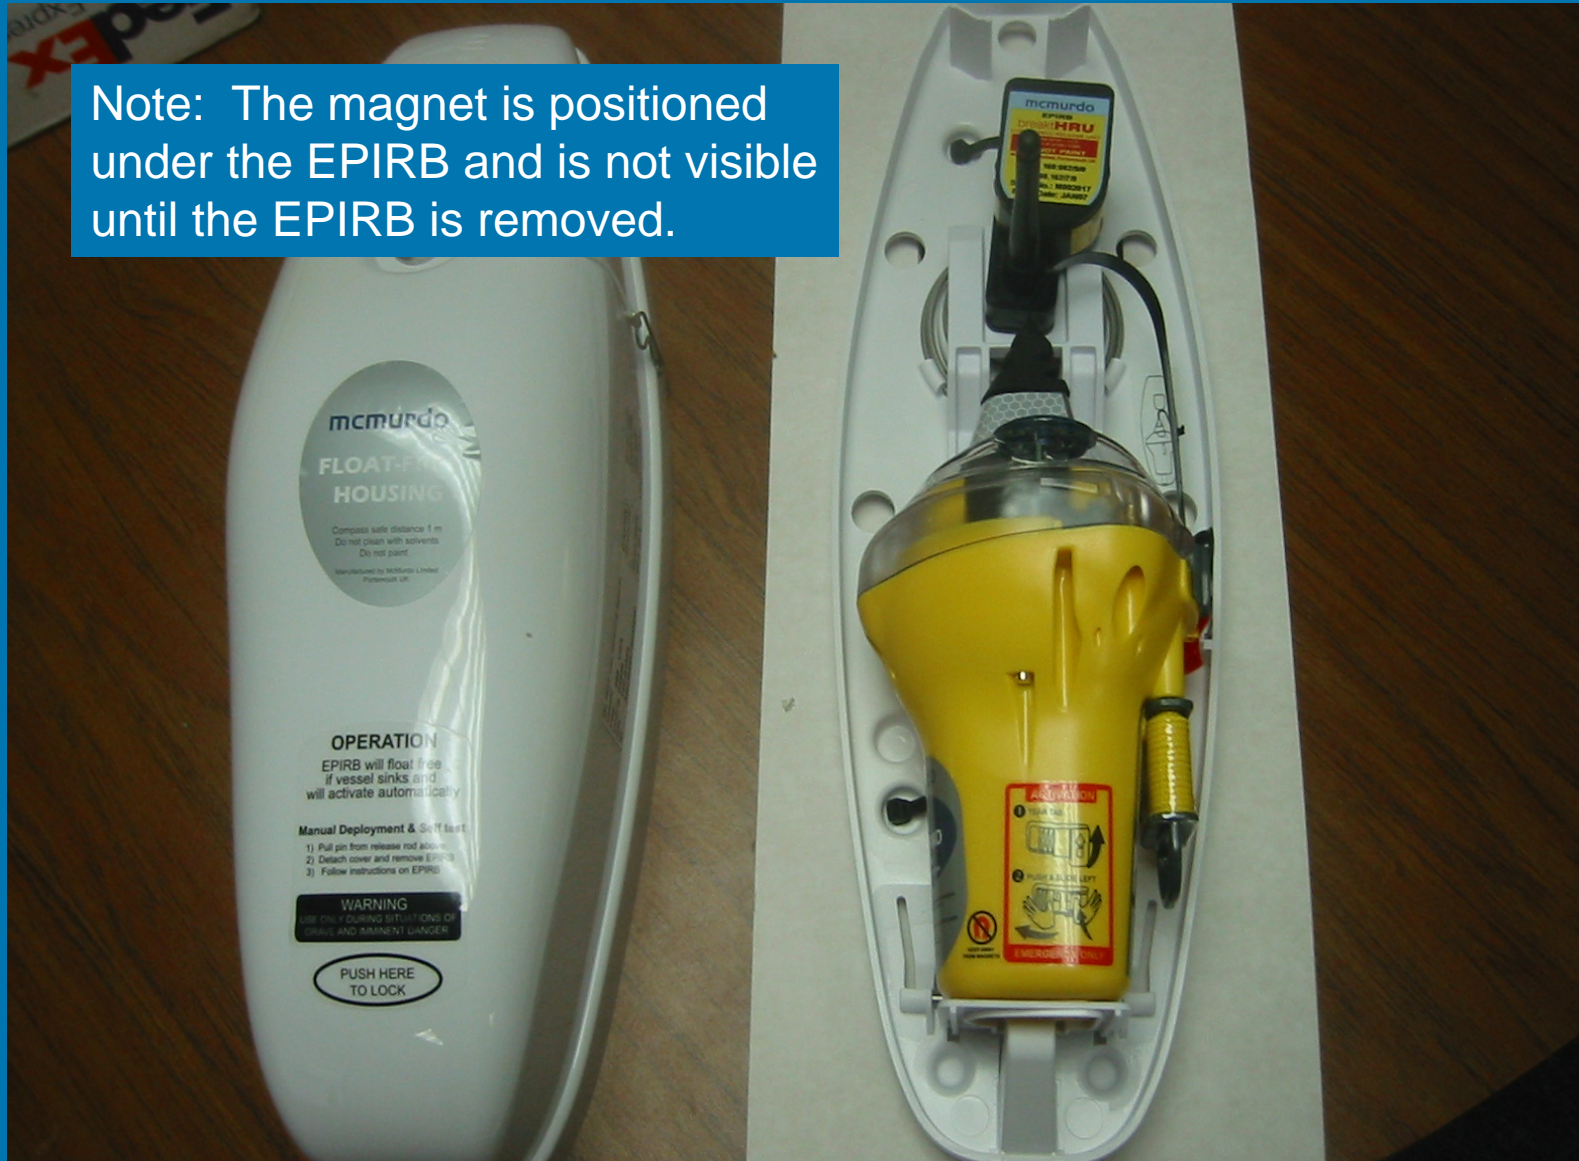
Category 1 McMurdo 406 GPS

Note: The magnet is positioned under the EPIRB and is not visible until the EPIRB is removed.

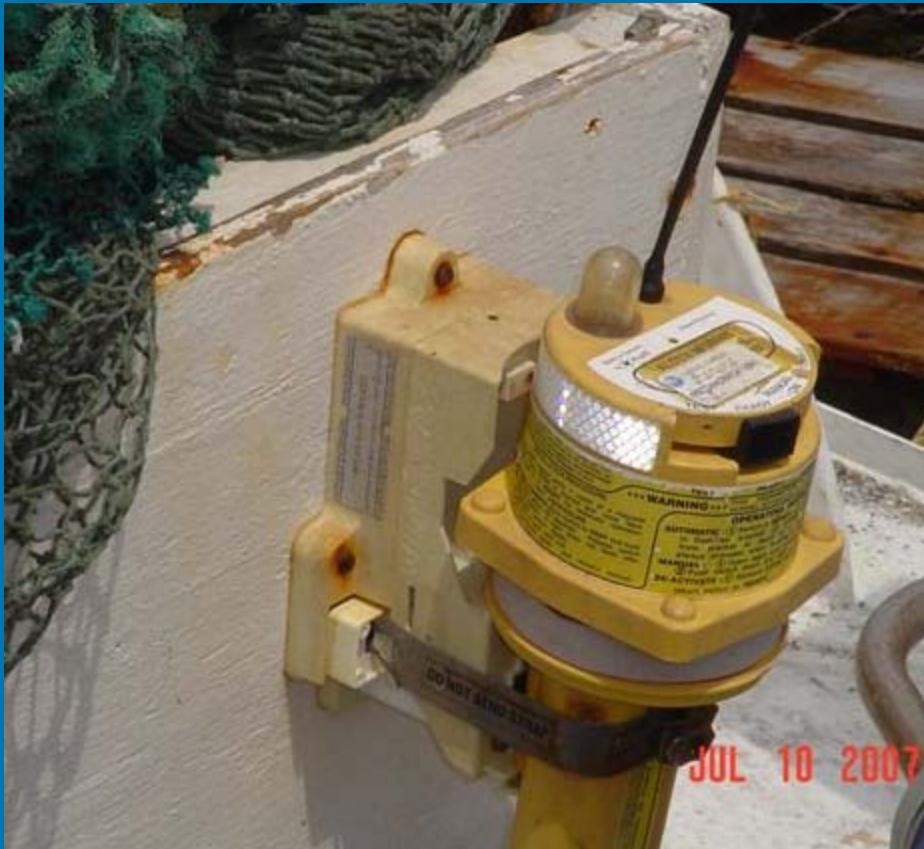
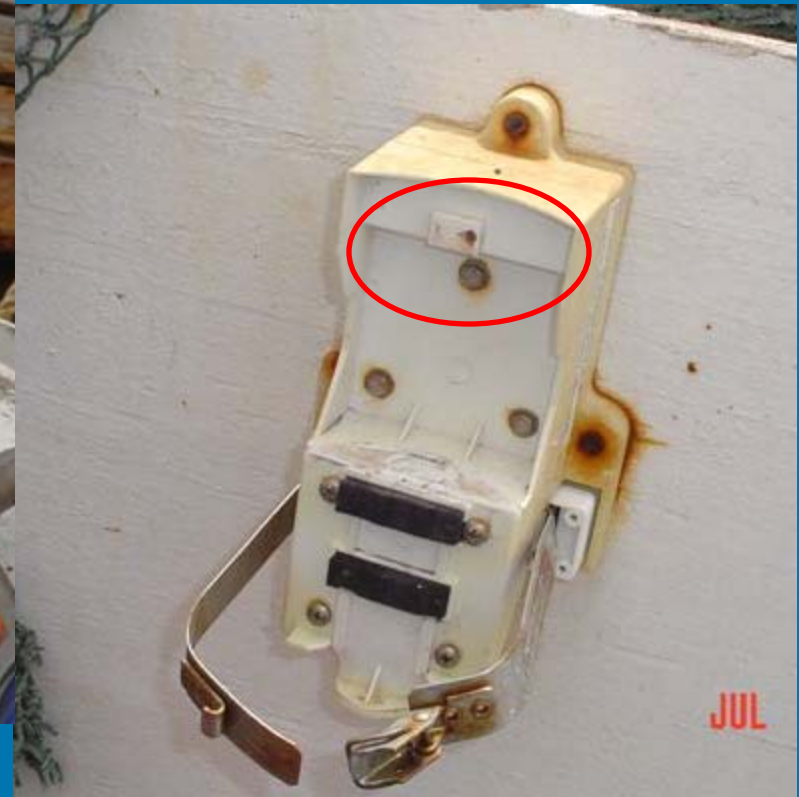
Alden / NAT S1010

- Magnet Location

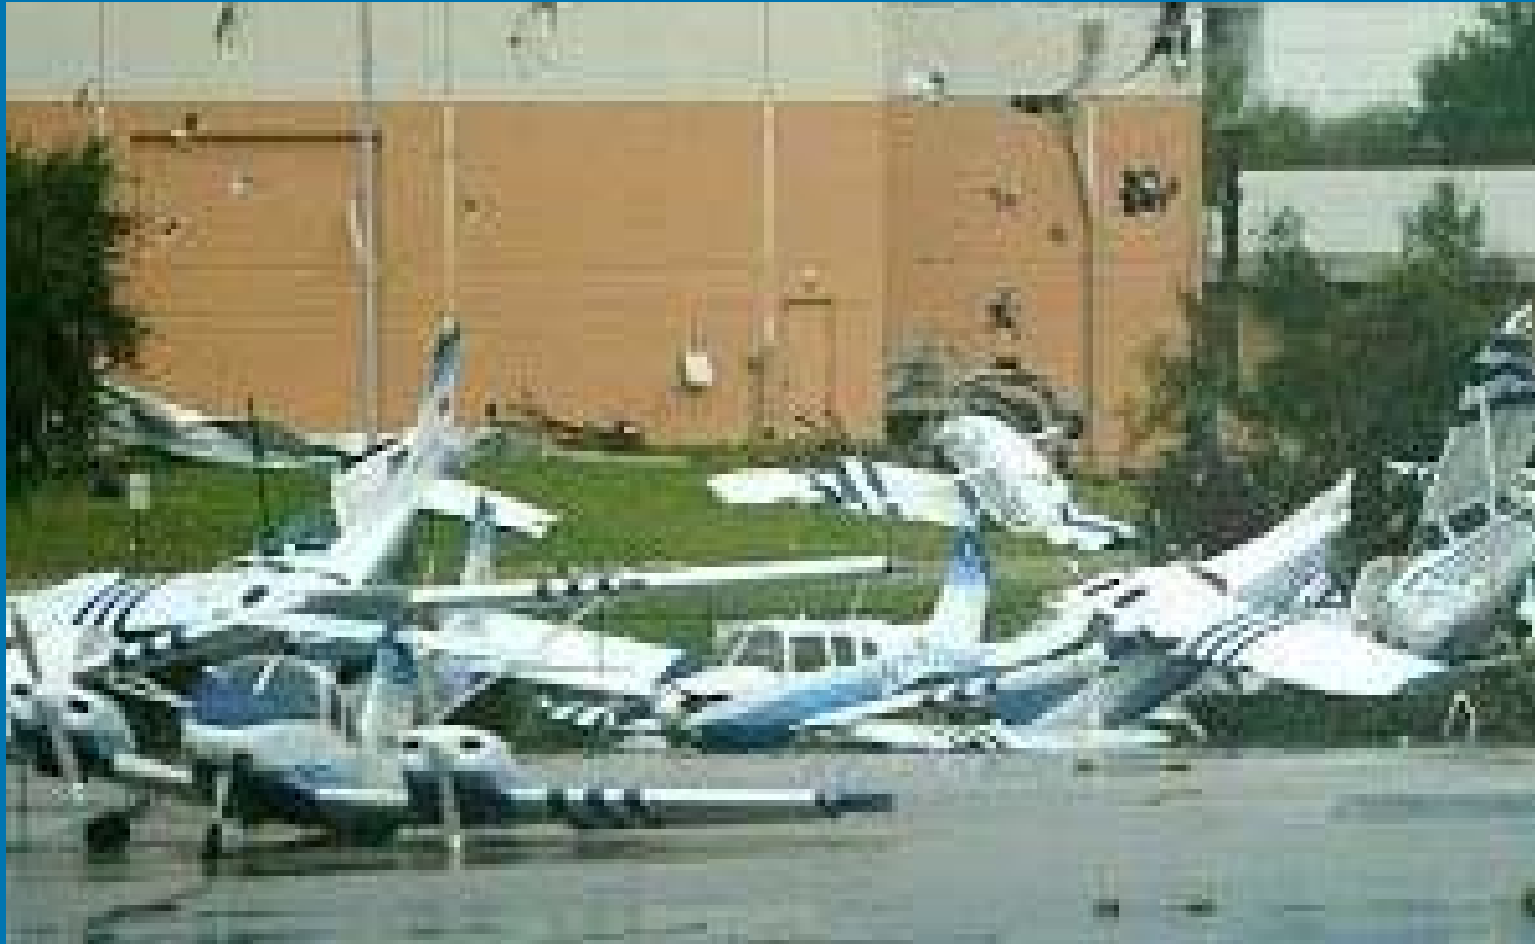
False Alert ELT – environmental Conditions - YES

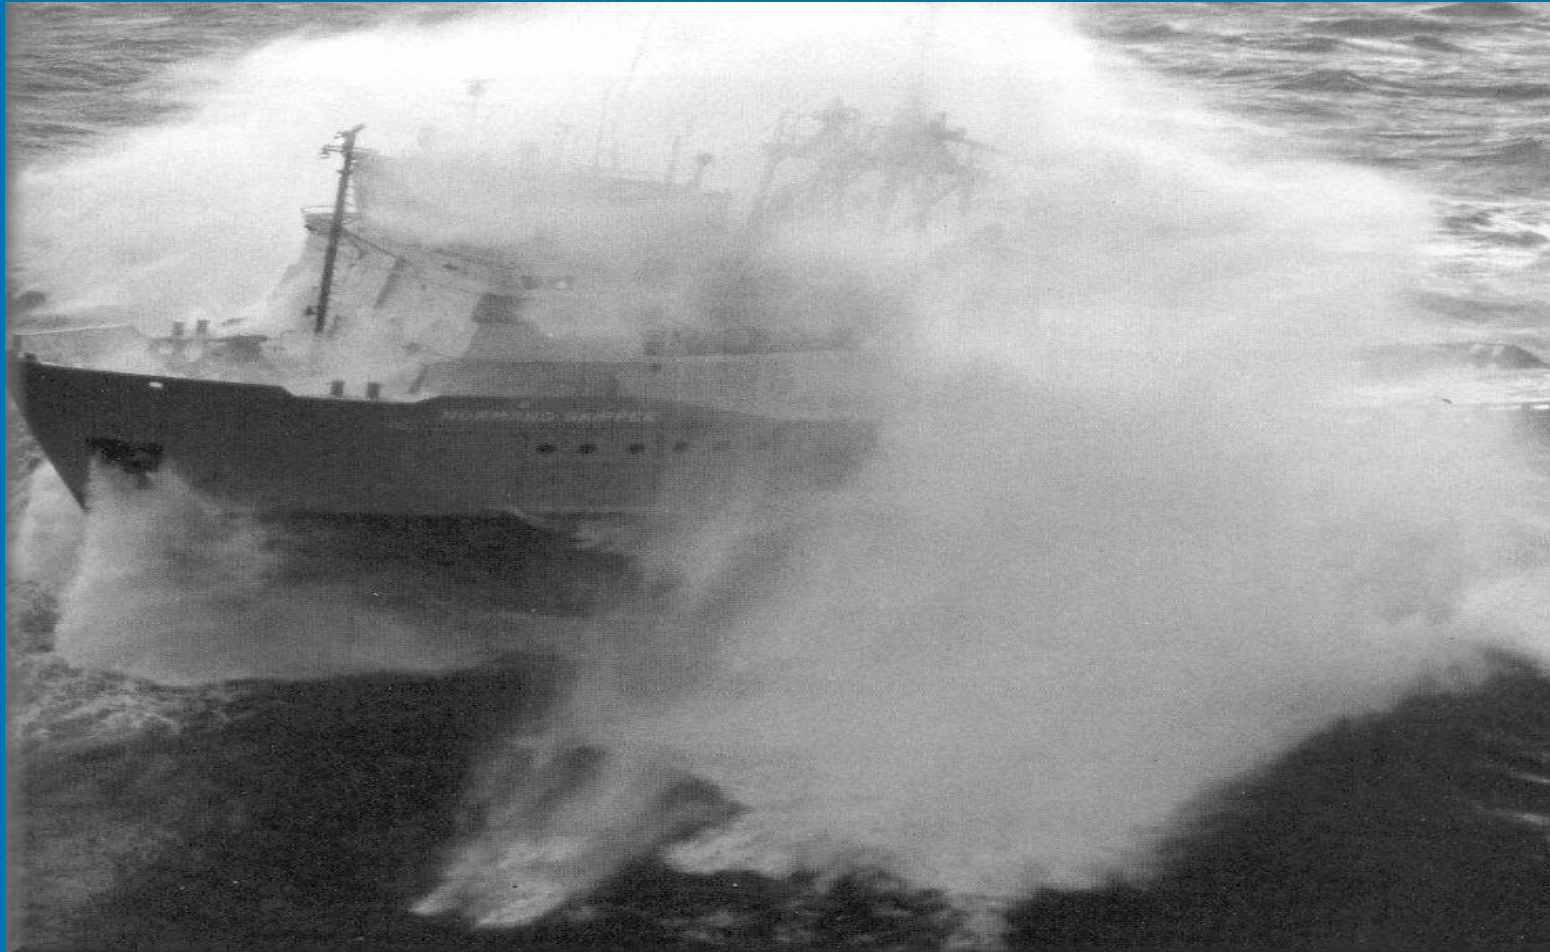
False Alert EPIRB– environmental Conditions - NO
